The Uniform Building Inspection Report™ Condensed

Single Family Residence:

4557 New Dupell Way, Las Vegas, NV

100110Prac

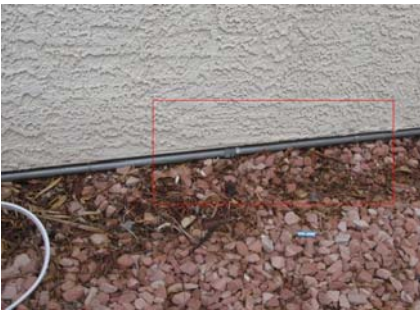
Photo: 0800.02 (1)

[N] [P] 0800.02: Earth separation from building inadequate. Keep all ground coverings at least 4-6" below the bottom of the stucco. This will allow visual inspection of the perimeter concrete foundation. Full visual inspection was not possible at the time of the inspection.
See series 0800.02 photo(s)

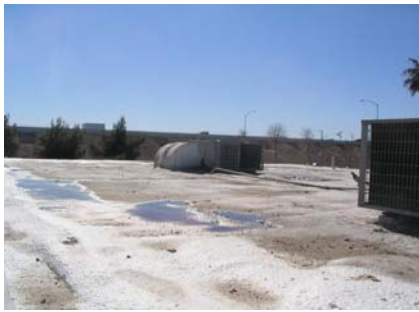
Photo: 1100.02 (1)

[R] 1100.02: Water pooling on roof. Have the roofer examine the low areas of the flat roof and make any necessary modifications and/or repairs.
See series 1100.02 photo(s)

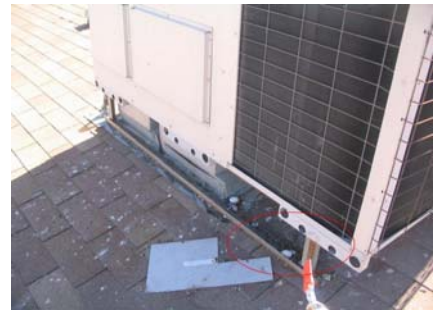
Photo: 2310.03 (1)

[P] [R] 2310.03: Condensate drain separated. Water has been draining through the unit and onto the shingle roof causing damage. Repair all condensate drains and make sure they do not drain on the roof. Noted on the roof.
See series 2310.03 photo(s)

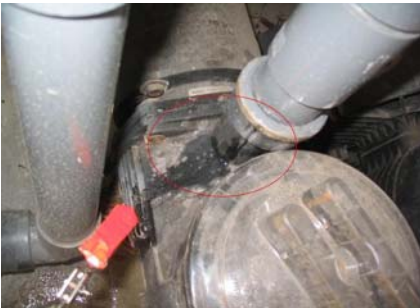
Photo: 3510.01 (1)

[R] [P] 3510.01: Pump appears to leak at shaft seal.
See series 3510.01 photo(s)

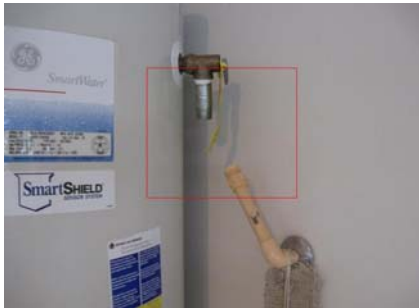
Photo: 4140.01 (1)

[P] [B] 4140.01: Water heater pressure / temperature relief valve discharge not terminated outside.
Noted in the garage.
See series 4140.01 photo(s)

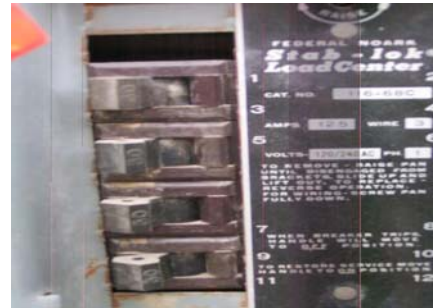
Photo: 5120.01 (1)

[R] [H] 5120.01: Breaker knockout missing from main panel (exposes bus bar).
Install new breaker knock-out to prevent shock hazard. The finding should be considered hazardous. Corrections by a qualified licensed contractor, before purchasing the property, are advised. Noted in the main panel.
See series 5120.01 photo(s)

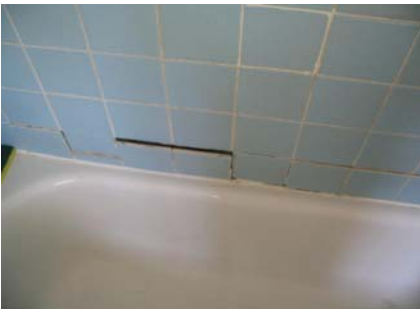
Photo: 6070.04 (1)

[P] 6070.04: Tile or grout loose.
Correction or modification decreases the probability of continued and excessive deterioration. Noted in the master bath.
See series 6070.04 photo(s)

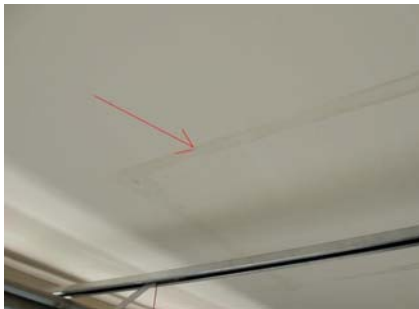
Photo: 7000.01 (1)

[M] [P] 7000.01: Stain noted on interior surface.
This is in the garage. Stains were dry at the time of the inspection. Correction or modification decreases the probability of continued and excessive deterioration. Monitor the situation on a regular basis.
See series 7000.01 photo(s)
