The Uniform Building Inspection Report™

Single Family Residence:

4557 New Dupell Way, Las Vegas, NV

1/10/2010, 11:00:00 AM

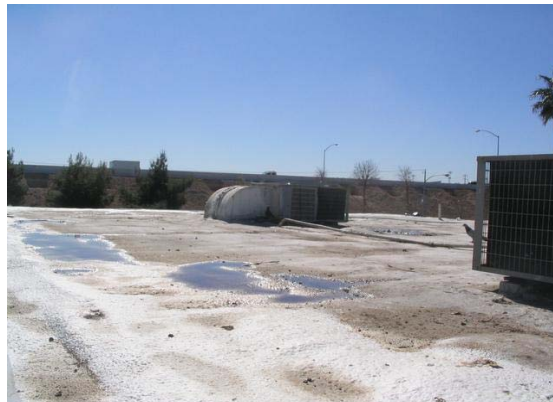
Photo: 1100.02 (1)

[R] 1100.02: Water pooling on roof.

Have the roofer examine the low areas of the flat roof and make any necessary modifications and/or repairs.

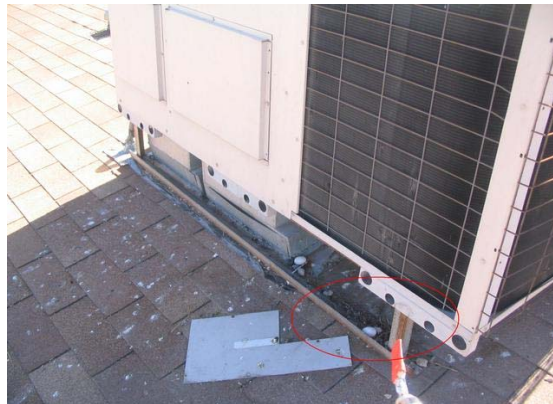
Photo: 2310.03 (1)

[P] [R] 2310.03: Condensate drain separated. Water has been draining through the unit and onto the shingle roof causing damage. Repair all condensate drains and make sure they do not drain on the roof. Noted on the roof.

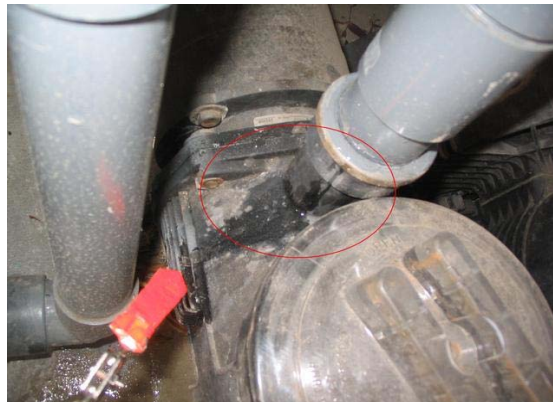
Photo: 3510.01 (1)

[R] [P] 3510.01: Pump appears to leak at shaft seal.
See series 3510.01 photo(s)

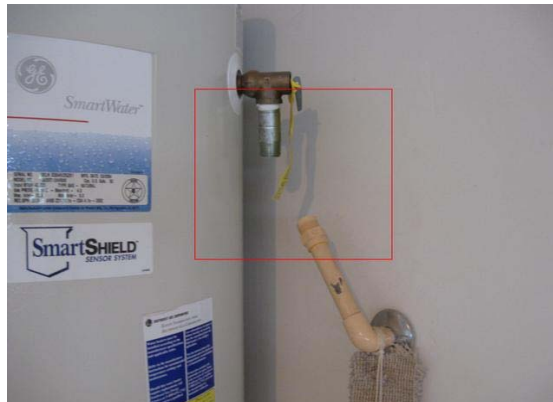
Photo: 4140.01 (1)

[P] [B] 4140.01: Water heater pressure / temperature relief valve discharge not terminated outside.

Noted in the garage.

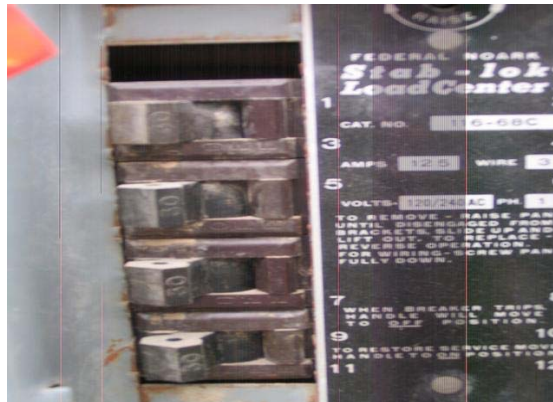
Photo: 5120.01 (1)

[R] [H] 5120.01: Breaker knockout missing from main panel (exposes bus bar).
Install new breaker knock-out to prevent shock hazard. The finding should be considered hazardous. Corrections by a qualified licensed contractor, before purchasing the property, are advised. Noted in the main panel.
See series 5120.01 photo(s)

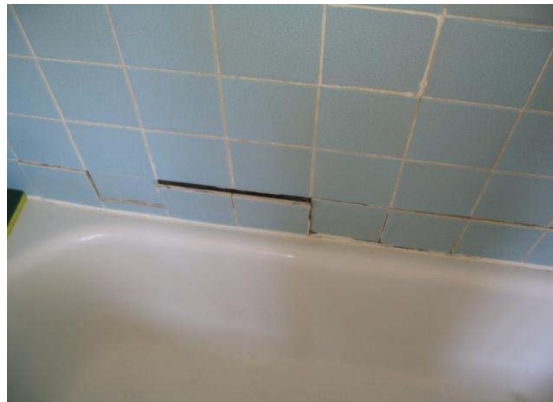
Photo: 6070.04 (1)

[P] 6070.04: Tile or grout loose.

Correction or modification decreases the probability of continued and excessive deterioration. Noted in the master bath.

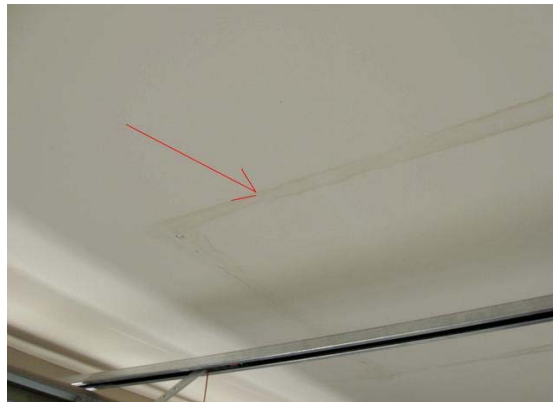
Photo: 7000.01 (1)

[M] [P] 7000.01: Stain noted on interior surface.

This is in the garage. Stains were dry at the time of the inspection. Correction or modification decreases the probability of continued and excessive deterioration.

Monitor the situation on a regular basis.
